Thermal imaging camera (TIC): What is it?

Why use a thermal imaging camera?

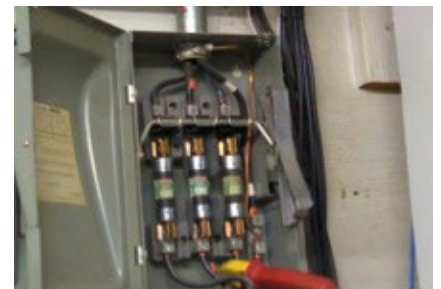
This image shows a typical disconnect box. When observed by the naked eye, nothing appears to be wrong.

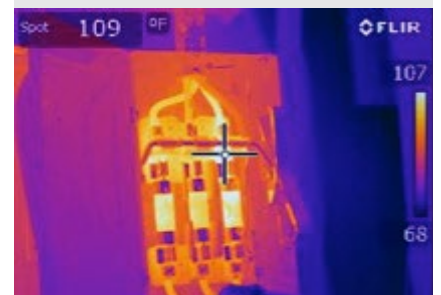
This is the thermal image of the same disconnect box. Note the abnormal heat level on the fuse clip.
